Our Ref: 12799.2/SK/DS/KW

RE: BRIDGWATER ARTS CENTRE – REPORT ON REAR EXTENSION

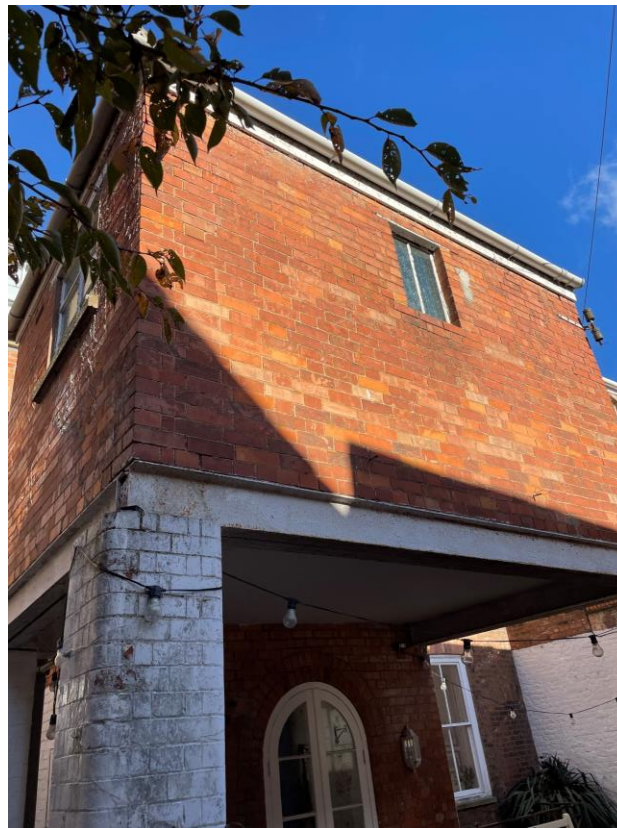
The rear extension is a single storey building at first floor level built off two rows of steels which are supported by brickwork piers at three corners and the main building on most of one side.

Figure 1: View from South West

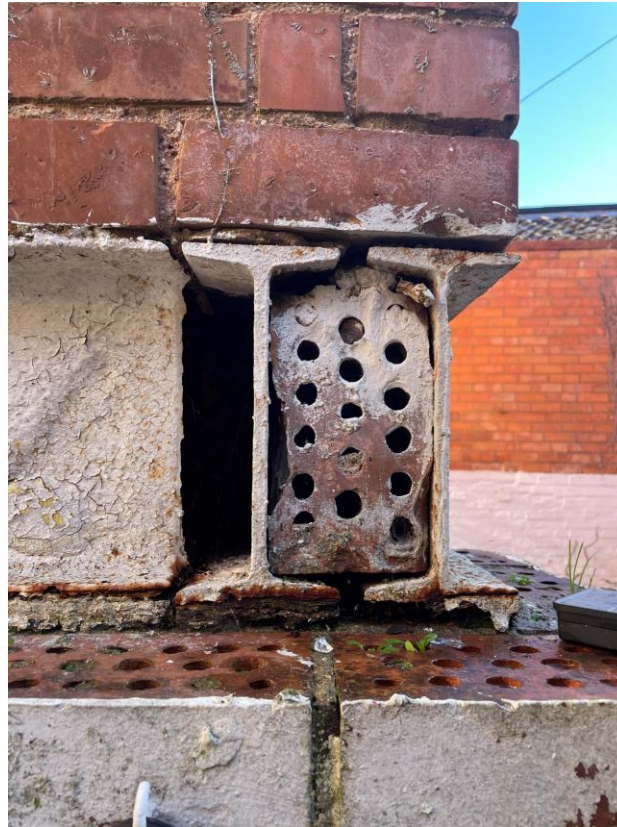
Figure 2: View of steels over SW column

This is supported by masonry walls on all sides and a concrete transfer slab providing the base for the first floor. The outer steels seem to support the roof and wall only, whilst the inner steels of each pair seem to support the roof and walls, as well as the transfer slab. The steels load onto masonry columns measuring approximately 450mm square. All the masonry columns appeared to be in a reasonable condition.

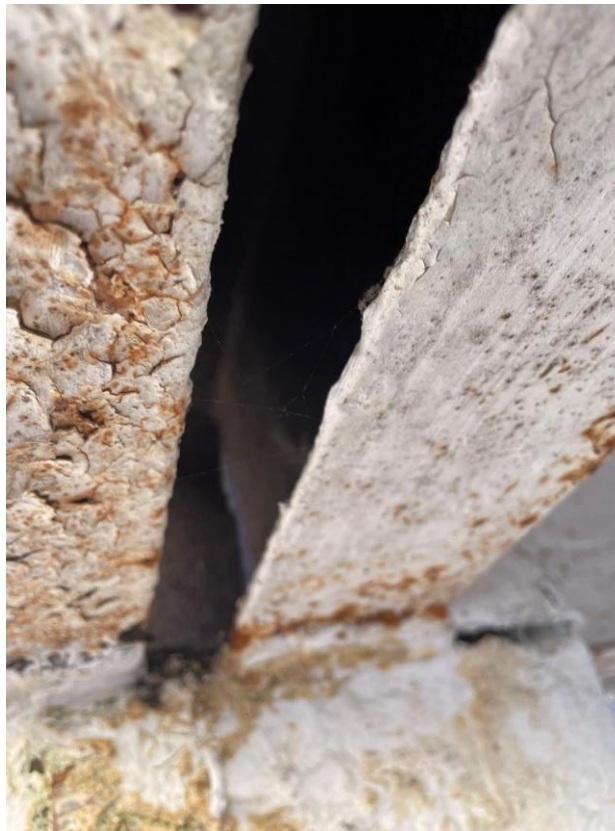
Figure 3: Underside of steels - demonstrating limited access to inside steel

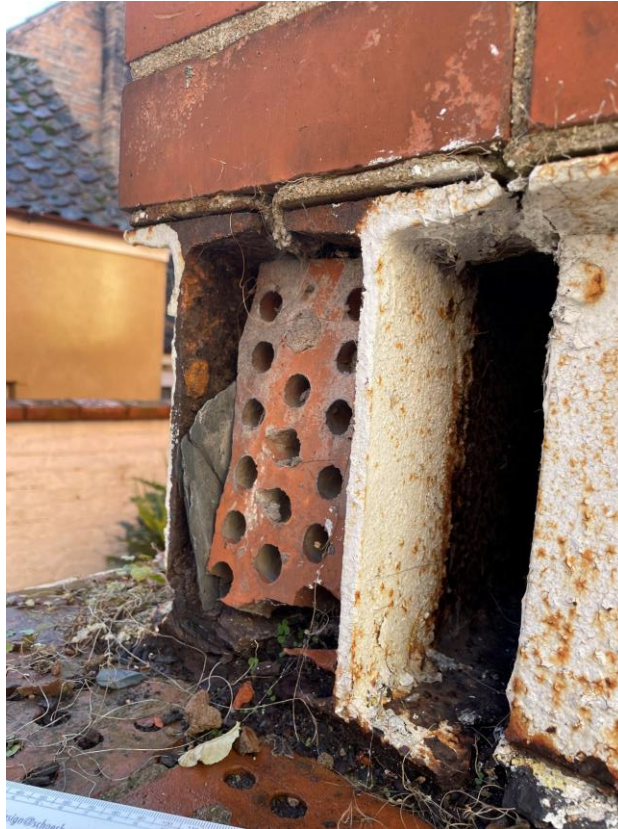
The steel's exposed location and inadequate protection has meant that they have been vulnerable to corrosion since their construction. In addition, the steels are landed on the tops of the brick columns which have a flat surface allowing rainwater to collect around the steels encouraging further corrosion. As a result, it was observed that the two rows of steels have undergone corrosion to various extents. Some areas are mild with loss of paint and loose scale, while other areas of the outer beams have lost a considerable amount of their cross-sectional area. The worst case being the outer beams directly over the south east piers (figure 4) where there is up to a 50% loss in area of the web and more than 25% loss of the bottom flange.

Figure 4: Heavy corrosion in outside steel above SE column

We would strongly recommend one of the following, which may depend on the medium to long term strategy of the building.

Thoroughly clean and strengthen the beams by plate welding. Then apply a high-quality paint protection system to as much of the steelwork as possible.

As Option 1 with the addition of flashing or covering to prevent standing water.

Replace the beams with galvanised ones and improve the detailing to prevent standing water

Take down and completely rebuild the extension.

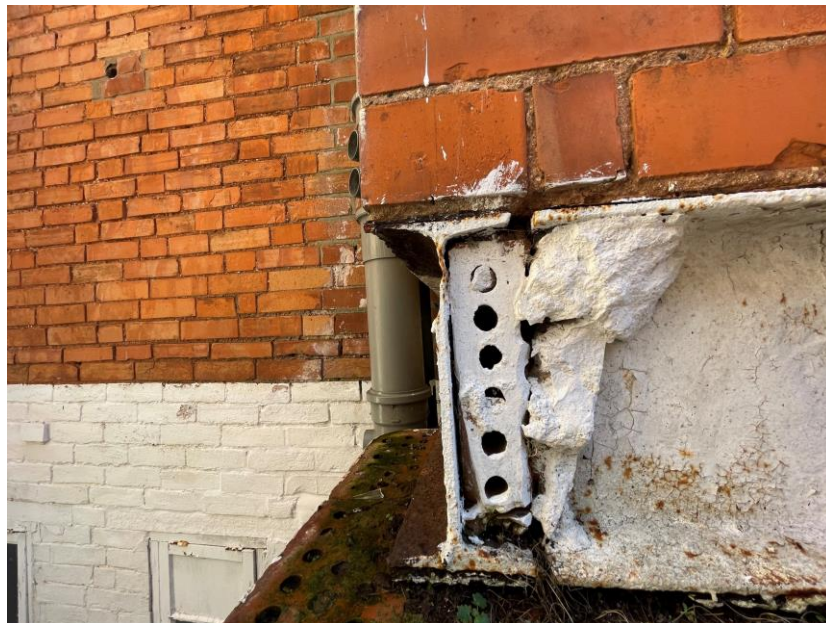
We have back analysed the beams under the loading observed on site and found that the outer beams in the south east corner will fail in web buckling. **In short, the vertical element of the beam is at risk of crushing because there is insufficient remaining steel thickness.** This has started, as shown in the buckle of the web in Figure 4 and Figure 5, and collapse is probably resisted by a combination of infill brickwork and slate, seen in the image and load transfer to the inner beam.

Figure 5: Web Buckling in steel above SW column (viewed from the south)
