Bridgwater Town Hall
Report on Refurbishment of the Town Hall Theatre
July 2022

REV A – July 2022

1.1 This report has been prepared by Philip Hughes Associates who have been appointed by Bridgwater Town Council. The aim of the report is to assess the Town Hall Theatre and Charter Hall and make recommendations on how the Theatre could be refurbished.

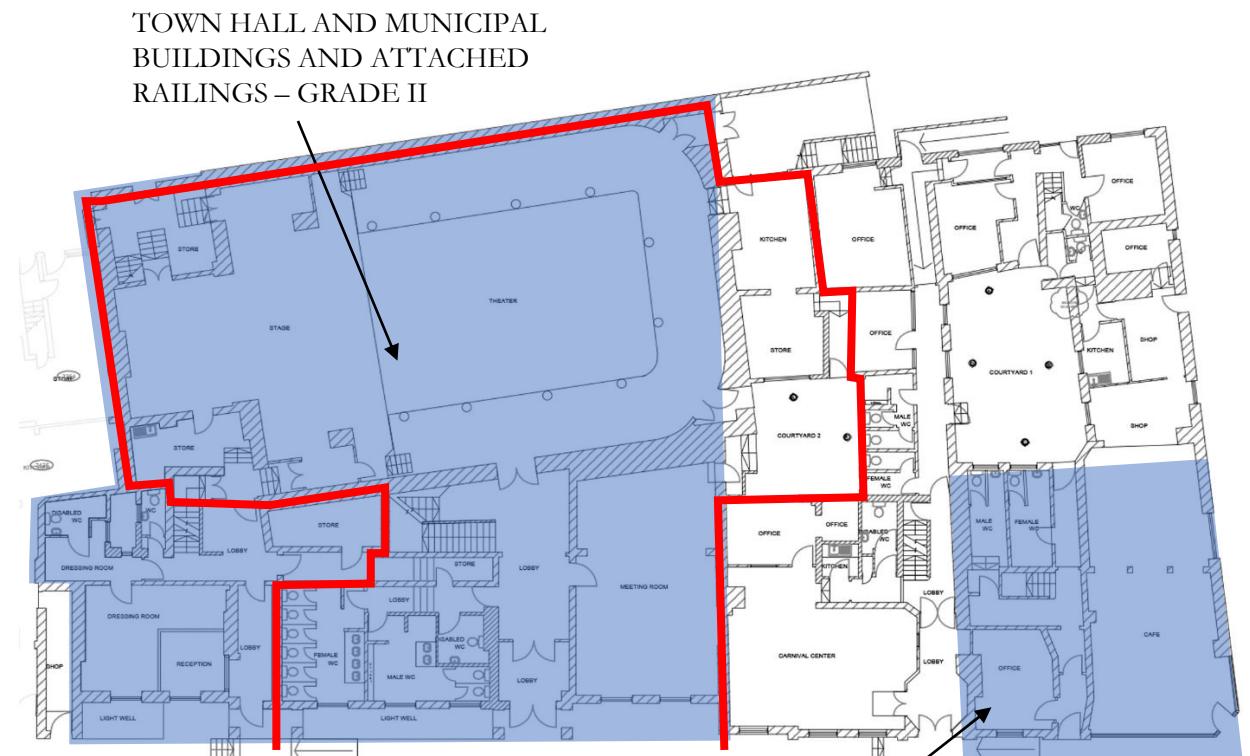
The ground floor plan below shows the boundaries of the two listed buildings as identified by Historic England with the outline of the theatre in red.

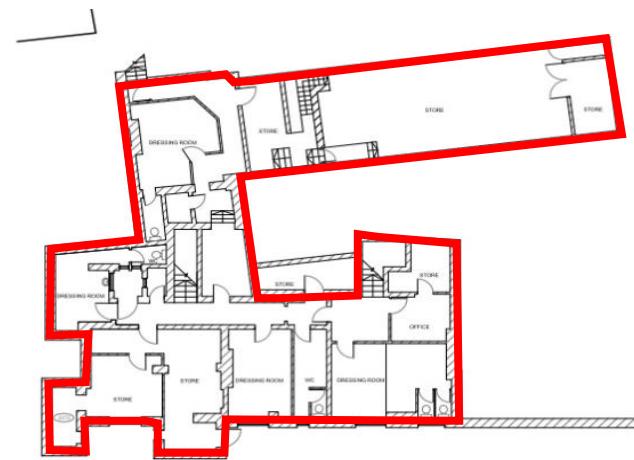
BASEMENT PLAN

3.2 At basement level the rooms occupy the area beneath the left hand side of the Regency building (they do not extend under the theatre foyer and Charter Hall) with an angled wing beneath the theatre auditorium.

3.3 The rooms beneath the Regency building are largely used as dressing rooms while the room beneath the auditorium is used for storage of seating for the Theatre. At the end of the theatre seating storage area is a scissor lift used for lifting the seating up to the auditorium.

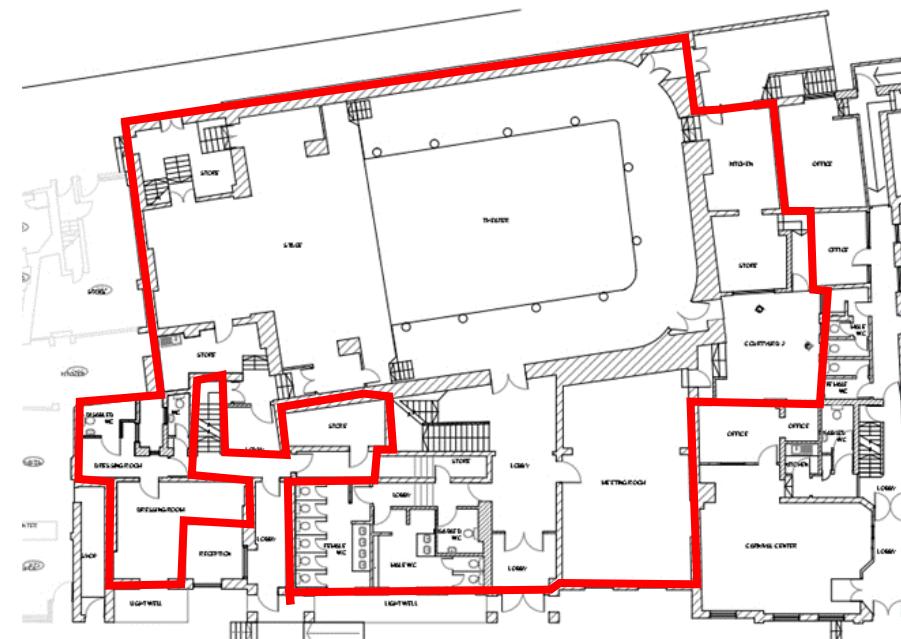
GROUND FLOOR PLAN

3.4 The entrance to the theatre is from the High Street via a pair of double doors to the right hand porch. This then leads in to the entrance hallway with male, female and a disabled toilet immediately to the left. Just beyond these is a small ticket booth and opposite the entrance to the Charter Hall.

3.5 To the far left of the foyer are the main stairs which lead upstairs to give access to the balcony seating level and the former Council Chamber.

3.6 The Charter Hall to the right of the foyer has two doors on its east side. The north door, behind the counter, leads to the enclosed courtyard and provides an uncovered connection to the kitchens across the courtyard that are located in the rear part of the 1950s section. The door midway down the east side (currently closed) connects to the ground floor of the 1950s section.

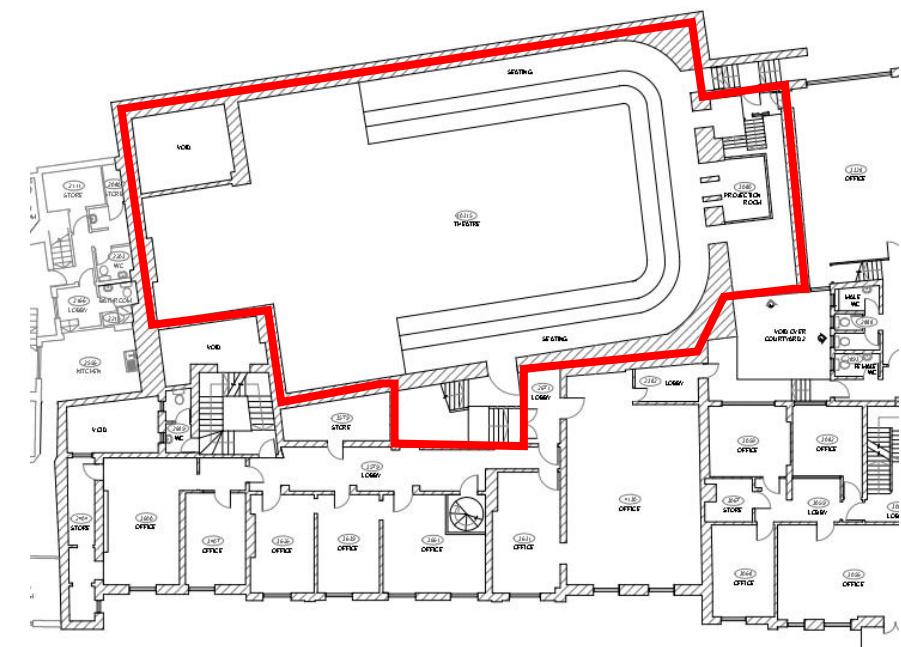
FIRST FLOOR PLAN

3.7 As described above access to the first floor is from the foyer staircase which first reaches the south door to the auditorium gallery and then reaches, via a further flight of stairs, a lobby which leads to the Council Chamber and the first floor Town Hall offices accommodation.

A projector room is located to the east of the auditorium at first floor level which is accessed from the 1950s section. There is also an escape door from the balcony here which leads to an external staircase.

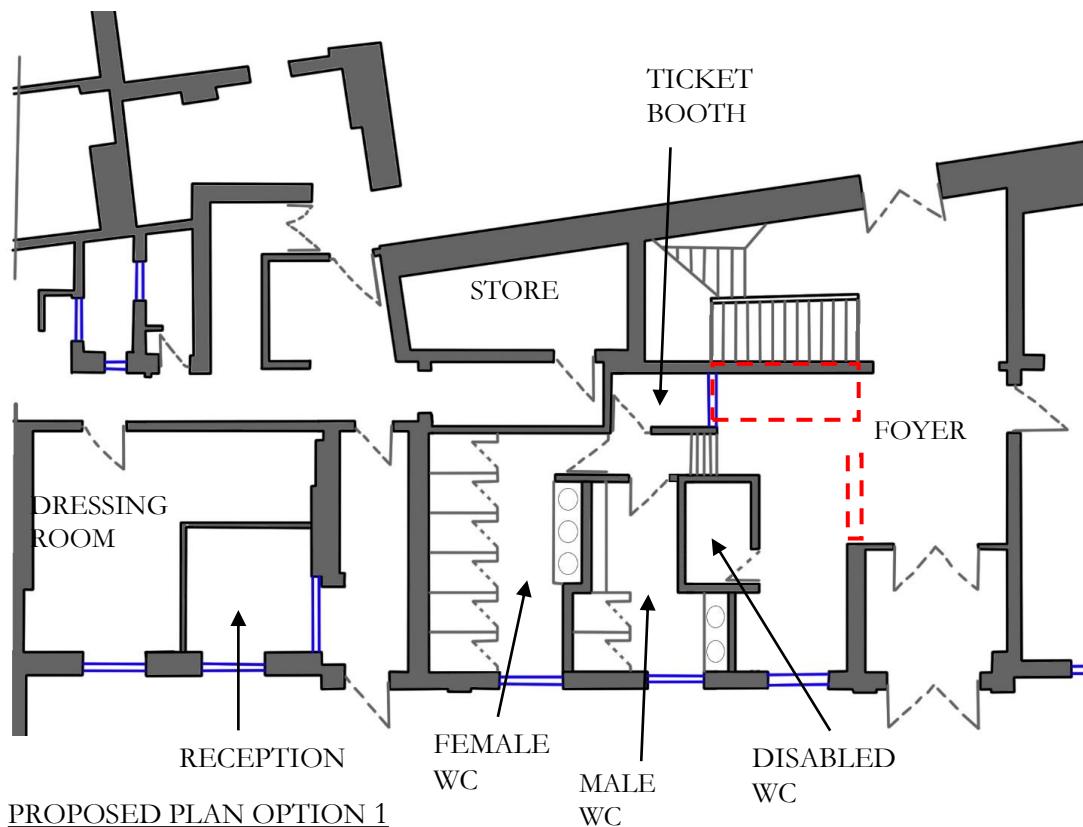
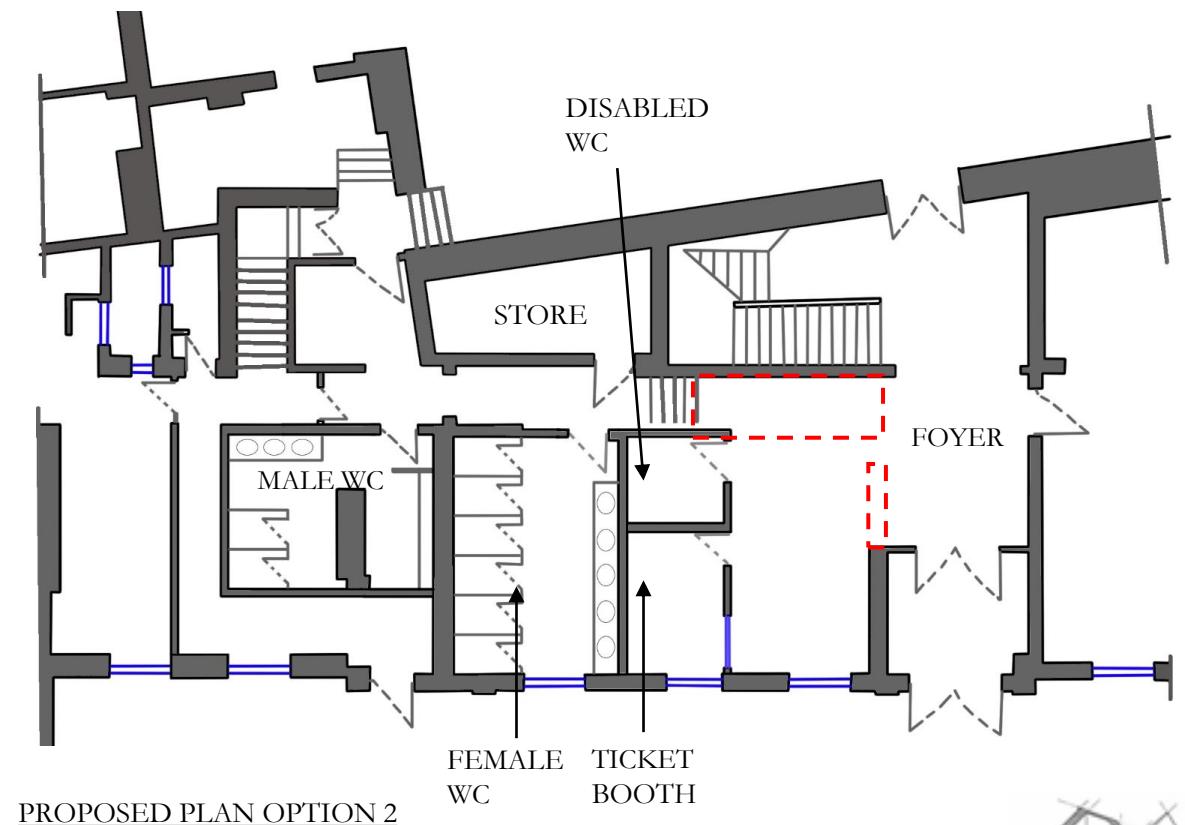
4.2 This could be achieved by re-arranging the toilets and ticket booth so that there is more available area in the foyer space. The diagrams below show two proposals for re-arranging this, summarised as follows:

1. The toilets are re-planned to use the space that they currently occupy more efficiently. This results in an enlarged foyer space immediately inside the entrance doors which pushes the toilets further away from the entrance and allows the ticket booth to be increased in size.
2. Utilisation of more of the ground floor space for the theatre. This would entail incorporating the room and corridor currently forming the town hall reception and theatre dressing room into the entrance spaces of the theatre. The toilets could be positioned here to give a larger foyer space that the first option described.

4.3 Both proposals would require reconfiguration of the internal walls and wall linings around the entrance space which might be considered controversial in terms of their impact on the historic fabric.

8.1 Two proposals for improving the foyer space are included (options 1 and 2). Option 1 proposes a remodelling of the space currently used by the toilets to increase the foyer space while option 2 proposes to make use of the entrance area of the town hall offices to gain more space. Option 2 has, on balance, too high an impact on the entrance area of the town hall offices and therefore option 1 is preferred.

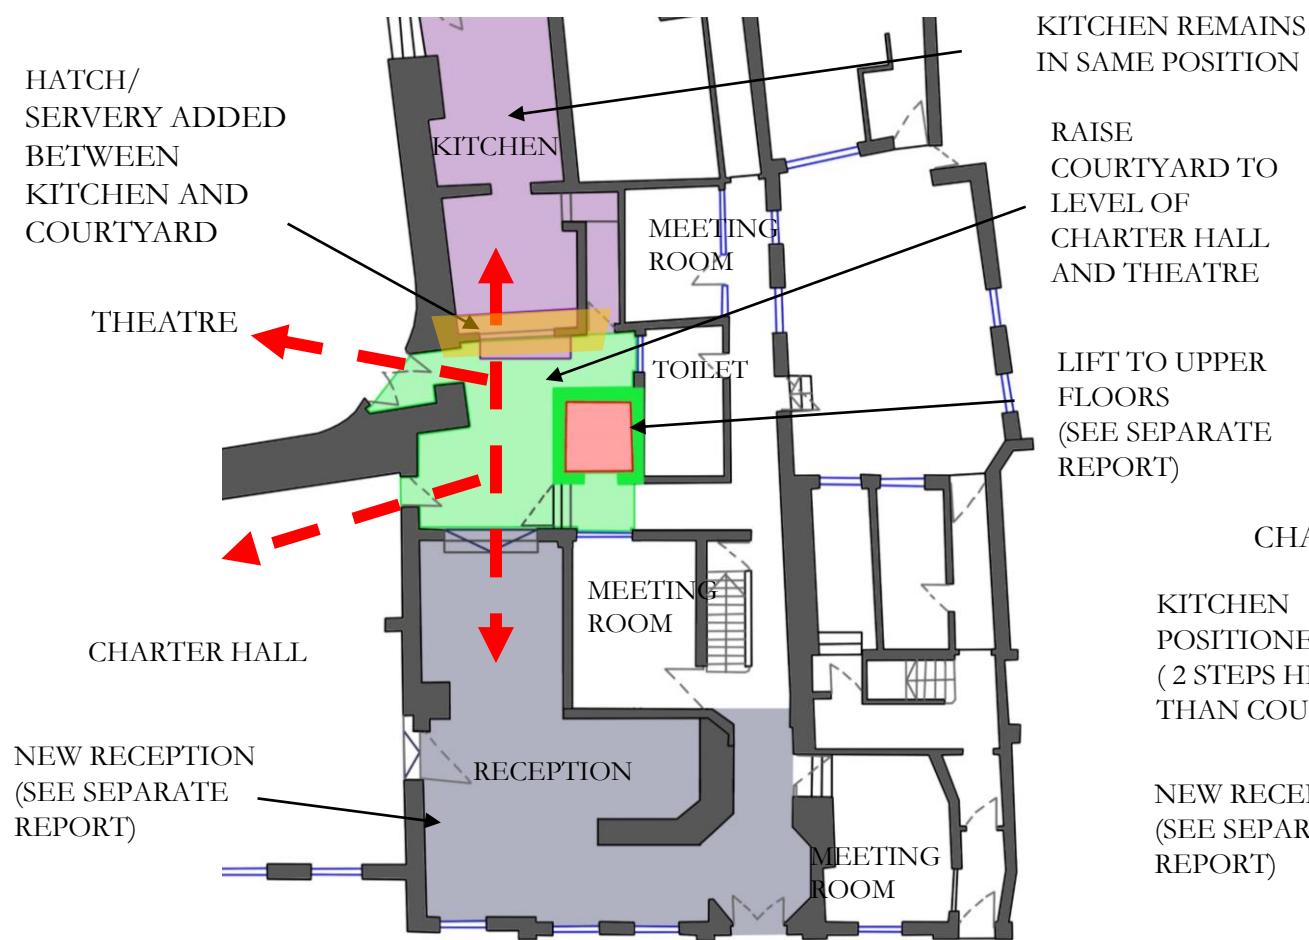
PROPOSED KITCHEN CONFIGURATION OPTION 1

1. Cover the courtyard to provide shelter between the kitchen and the Charter Hall. Covering the courtyard would also allow the removal of some of the level changes as the steps up at thresholds are believed to have been added to alleviate the risk of flooding from the enclosed courtyard.
2. Improve the connection of the kitchens to the courtyard space by adding a servery from the kitchen to the courtyard. This would allow a more direct connection to be made to the Charter Hall. This approach is shown on the left hand diagram titled Option 1 below.

8.2 The proposals for this area (options 1 and 2) aim to achieve a better linkage between the Charter Hall, kitchens and any remodelling undertaken to incorporate a reception and new lift in this area of the building. The proposal to position the kitchen (option 2) in the rear of the space occupied by the Carnival Centre does provide better connectivity to the Charter Hall but it does present problems in terms of the use and servicing of this space. Deliveries and waste storage and collection would be problematic and the space formally used by the kitchen becomes redundant (shown as storage on our plans). Option 1 which improved the connection of the kitchen in its current location with the Charter Hall by providing a servery from the kitchen and by raising the courtyard level to match the Charter Hall and Theatre is therefore preferred.

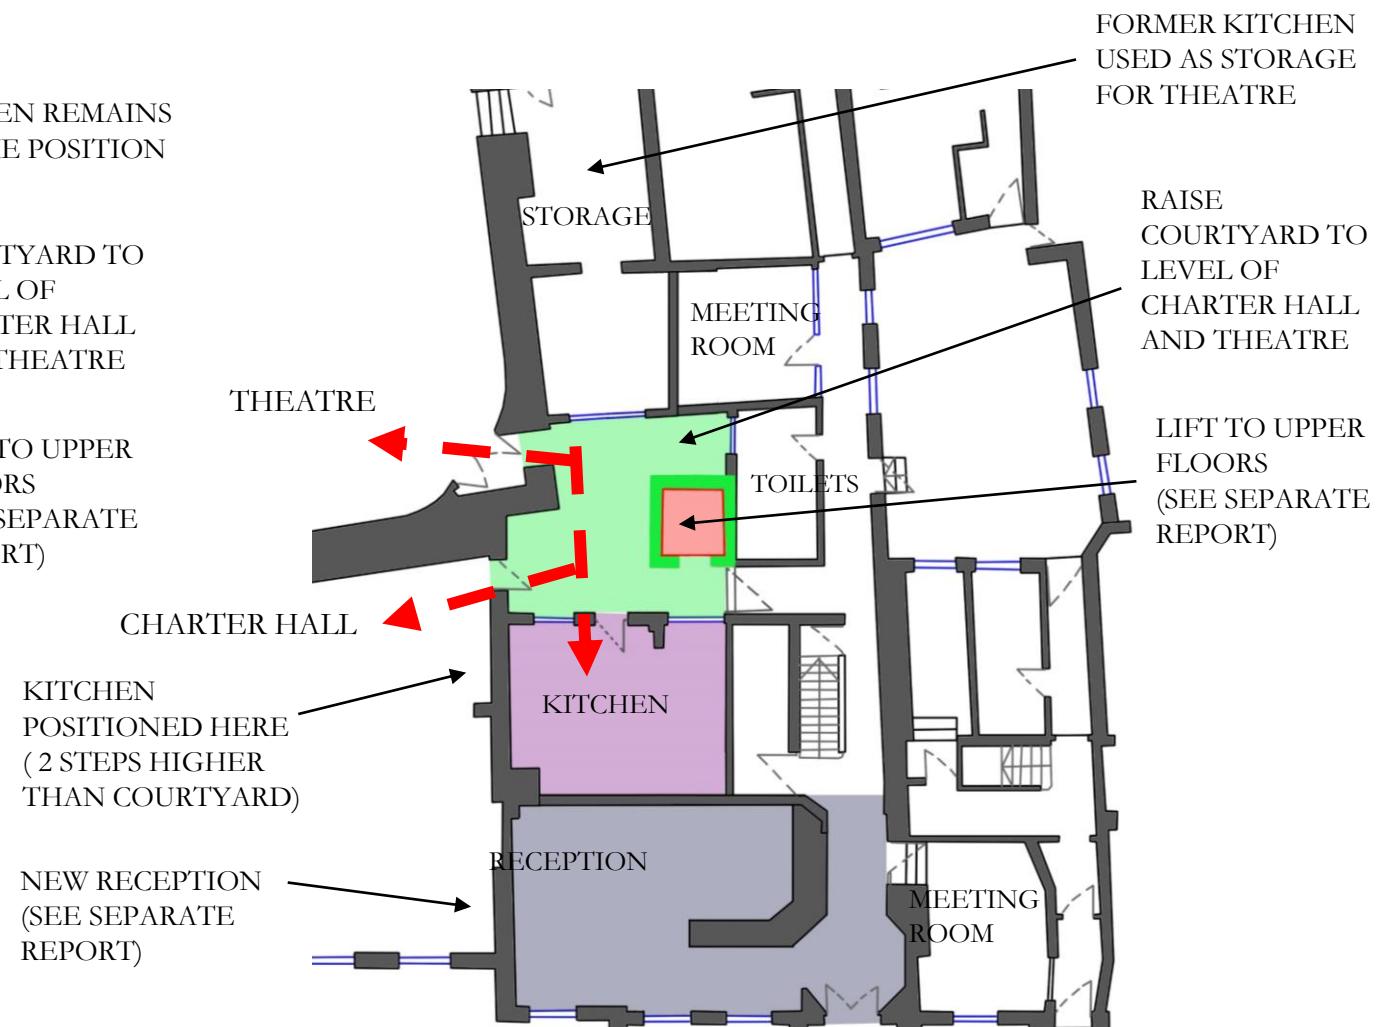
PROPOSED KITCHEN CONFIGURATION OPTION 2

3. Relocate the kitchen to the rear of the rooms currently used by the Bridgwater Carnival Centre immediately adjacent to the Charter Hall. This would allow a more direct connection to be made to the side door to the Charter Hall. It would however require the Bridgwater Carnival Centre to be relocated or reduced in size.

The kitchens in this space would have a better relationship with the Charter Hall but would be harder to service, in particular there would be no direct access to a road from which deliveries could be made and refuse stored and collected. This approach is shown in the right hand diagram titled Option 2 below.

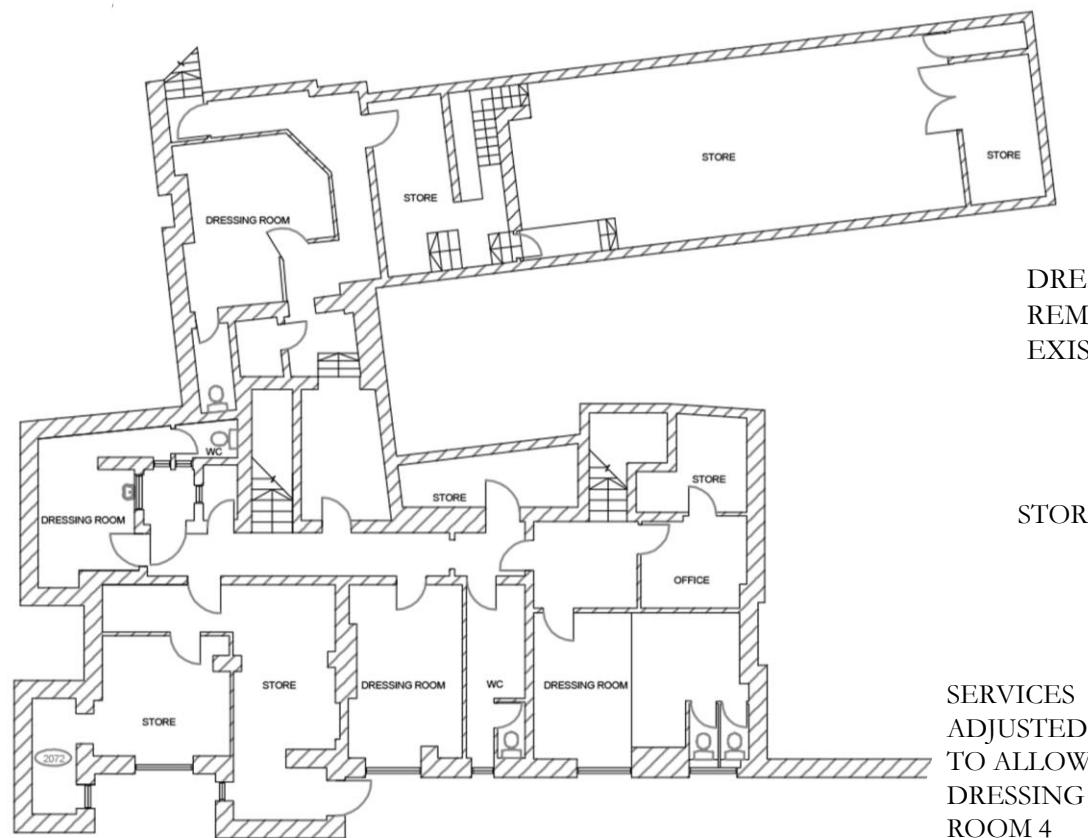
EXISTING BASEMENT PLAN

5.1 The arrangement of the dressing room spaces in the basement is awkward and they do not utilise the space available efficiently. The two rooms at the west end fronting on to the High Street are not available for use as they have pipework below ceiling level that prevents their use.

5.2 The spaces are suffering to varying degrees with dampness, in particular the dressing room at the far west of the building suffers the most with dampness.

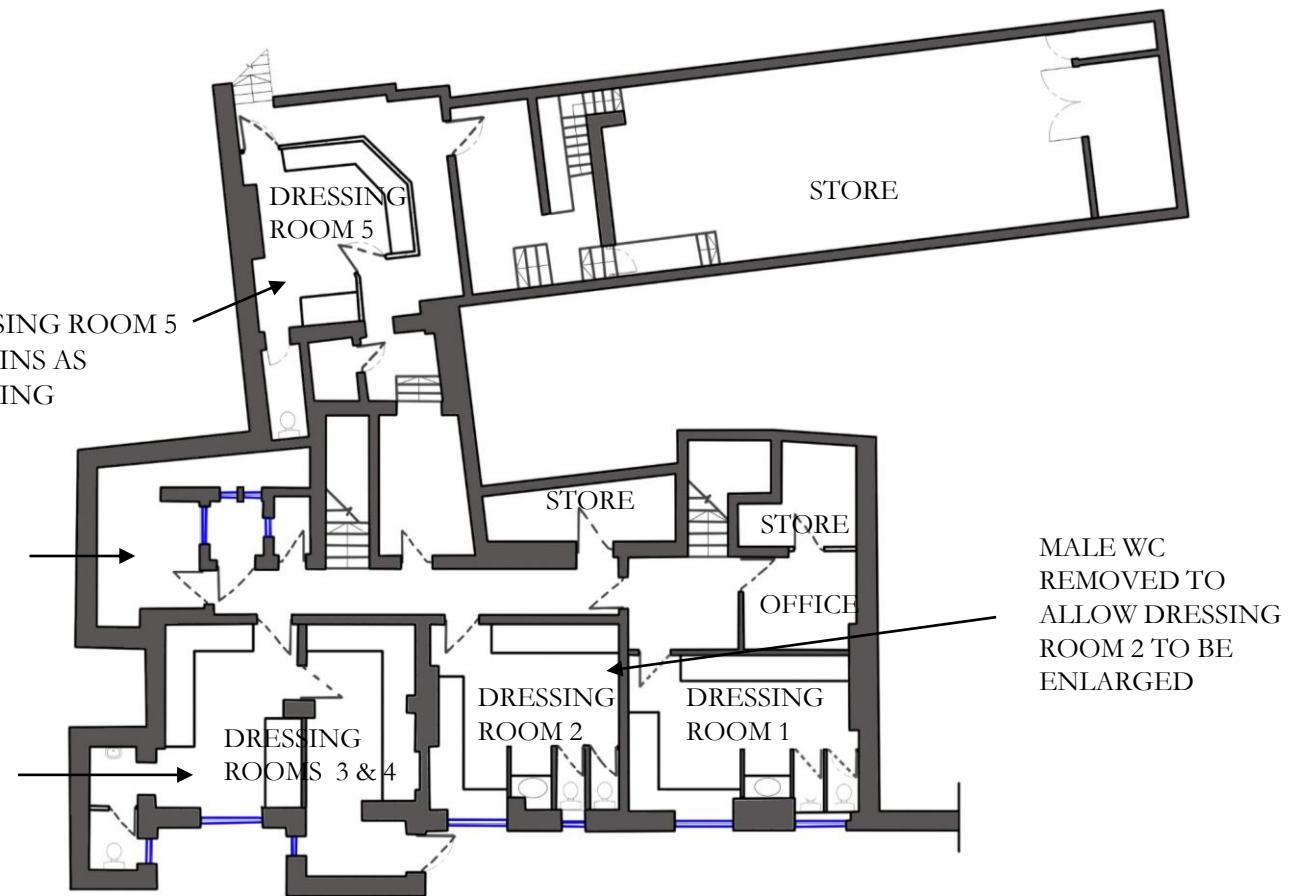
PROPOSED BASEMENT PLAN

5.3 The diagram below shows a possible reorganisation of the basement dressing rooms which gives the same number of dressing rooms (4) for performers to use. This is achieved by doing the following:

- Dressing room 1 at the east end remains as currently arranged.
- Dressing room 2 in the centre is enlarged by combining it with the separate male toilet. The dressing room has two toilet cubicles within it.
- Dressing room 3 is created by adjusting the services in the room so that it becomes usable. A WC is added in the store room to the west.
- Dressing room 4 remains as currently arranged due to the position of doors to this space and circulation required.
- The dressing room at the far west end is shown as a store due to its high levels of dampness but could be utilised as a 5th dressing room.

8.3 The improvements proposed will provide better and more flexible dressing room spaces by simplifying the arrangement of the rooms and giving each its own WC. Dealing with the issues of damp by removing non-breathable finishes and introducing ventilation to the spaces should improve the environmental conditions in these areas. All rooms require refurbishment and updating to bring them to a standard suitable for their use.

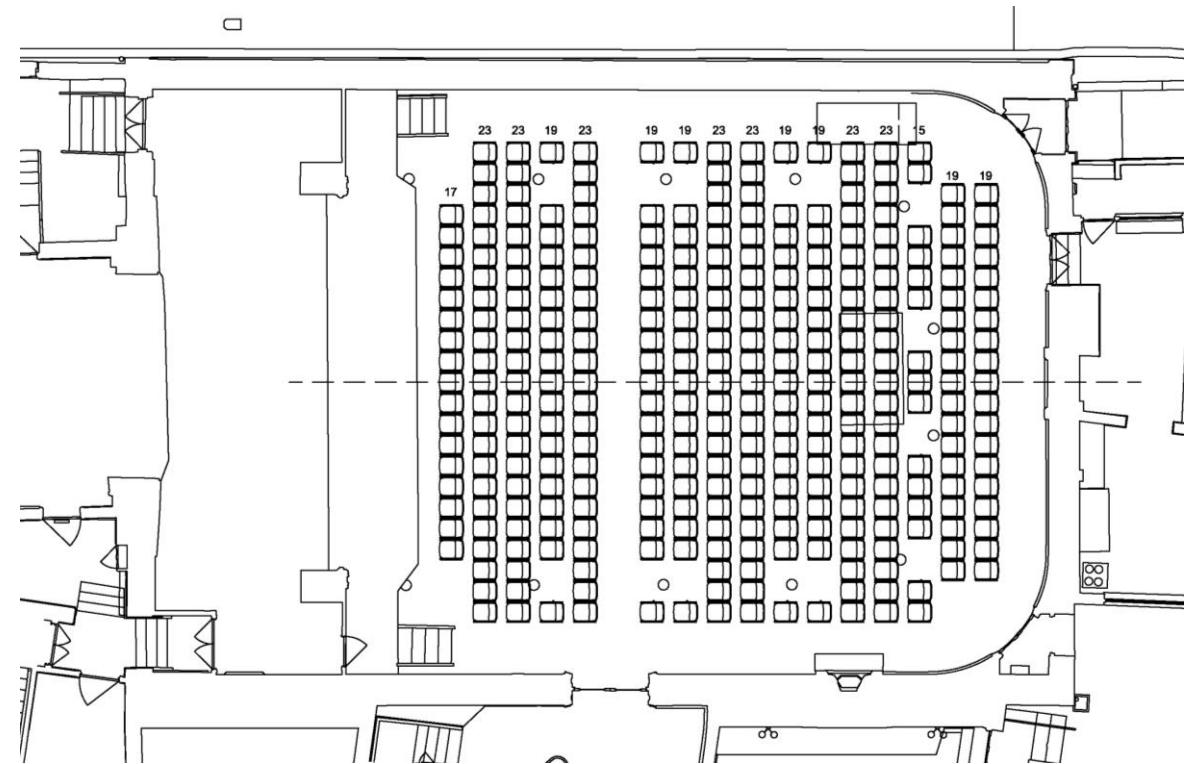
PLAN OF AUDITORIUM WITH STACKING CHAIRS

6.5 Based on the layout drawn opposite using chairs in rows 800mm apart we have positioned 326 chairs in the lower plan of the auditorium. The balcony level, due to its layout, is expected to achieve 115 seats as currently arranged.

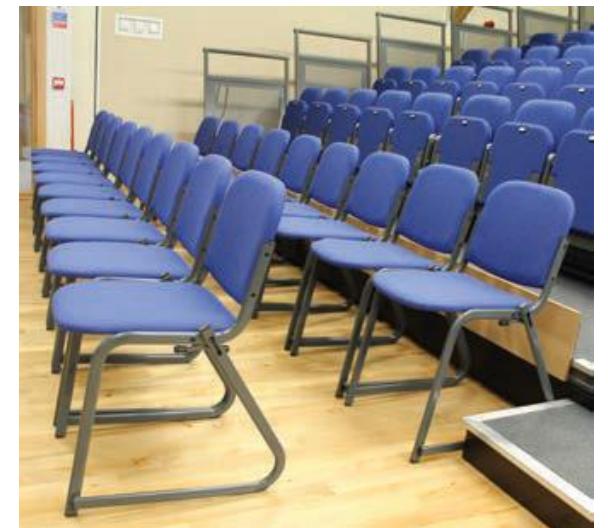
6.6 The Matrix System is a simple and compact removeable seating system. Groups of chairs are slotted into a matrix of floor bars with no floor fixing required. Chairs are in groups of 1, 2 or 3 which then interconnect side to side to form straight rows. Chairs are stored on trolleys with a maximum of 14 frames (42 chairs) per trolley.

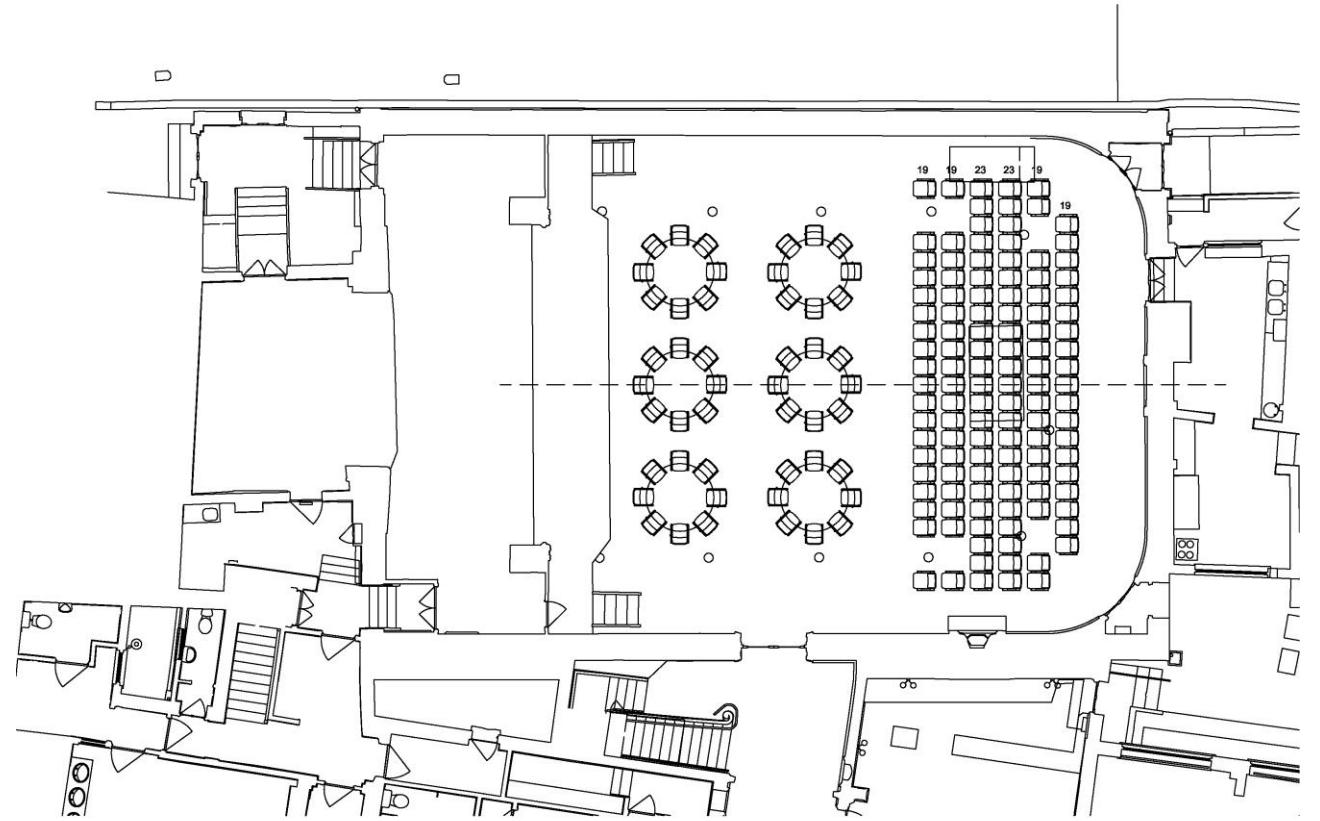
6.8 It would be possible to mix the matrix system with stackable chairs so that there are fixed rows of seating and an area of flexible unfixed seating that could be populated as wished with stacking chairs depending on the event being catered for. In the diagram opposite the rear six rows are shown with the matrix system left in place and the front area laid out for a banquet using stackable chairs.

PLAN OF AUDITORIUM WITH MATRIX SYSTEM TO REAR 6 ROWS AND
REMAINDER WITH STACKING CHAIRS TO SUIT BANQUET

8.4 Proposals for chair storage aim to improve the ease by which the chairs can be put out whilst also maintaining enough flexibility so that the theatre auditorium can be utilised for a range of uses. Stackable seats give the most flexible arrangement but may not offer the speed of erection that the matrix system offers. The proposals suggest that a hybrid approach could be investigated which would allow the theatre to provide flexible layouts for some uses with the remainder as more rigid matrix system seating.

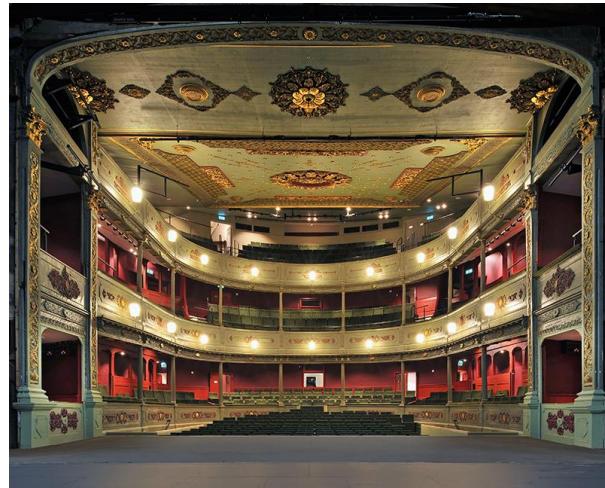
VICTORIA PALACE THEATRE, LONDON

7.8 Below are two images of the Victorian Palace Theatre in London. This theatre was built in 1911 so it is not technically Victorian but does provide an example of how a large theatre space might be treated to create more intimacy – in this case by adding depth to the balcony spaces and decorating the ceiling in a darker shade to reduce its impact.

7.9 The images on the right show the theatre space with a shaded ceiling and use colours from a green Victorian palette.

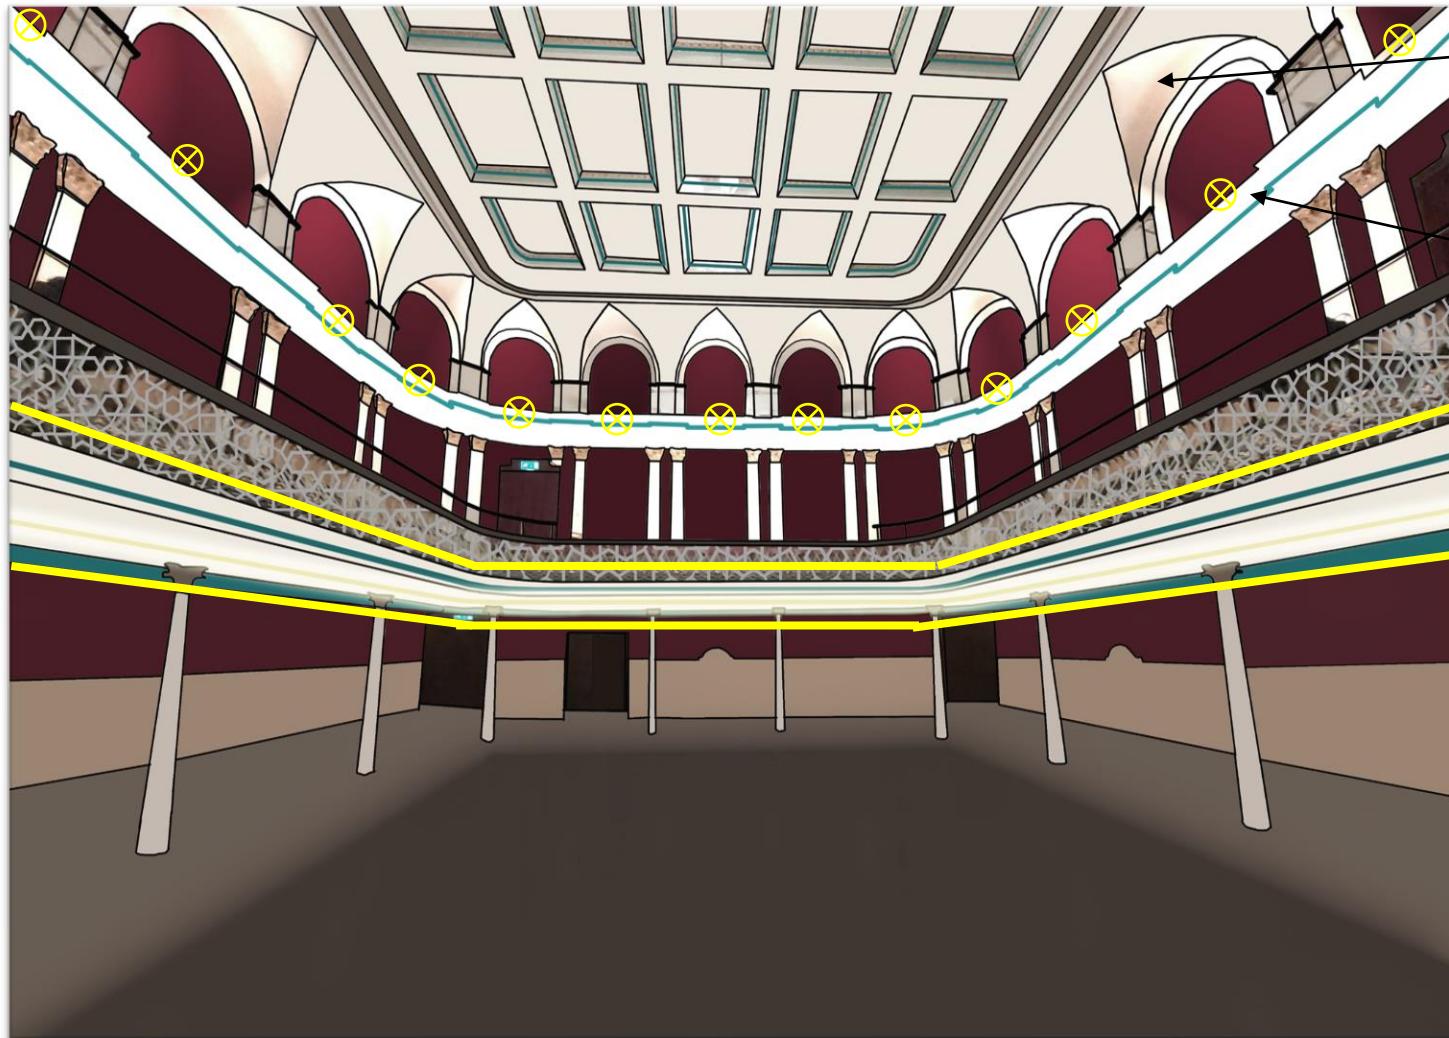
PROPOSED LIGHTING IN AUDITORIUM

7.10 The image below shows a proposed approach for lighting the space that seeks to illuminate the upper parts of the auditorium more successfully by positioning lights in the centre of the niches which wash light up towards the underside of the barrel vaults to better illuminate this detail.

7.11 The balconies are brought forward in to the space more by illuminating above and below with continuous lighting, either via strip lights or by closely placed individual lights.

PANELS AND
BARREL VAULTS
ILLUMINATED

INDIVIDUAL LIGHTS
WITHIN NICHE PANELS
WASHING LIGHT UP
TOWARDS THE
UNDERSIDE OF THE
BARREL VAULTS

CONTINUOUS LIGHTING
ABOVE AND BELOW
THE BALCONY

8.7 The lighting scheme proposed in this report uses an approach that aims to illuminate the architectural features of the auditorium more strongly than is currently achieved. This is one approach but there are a multitude of approaches that are needed if the auditorium is to be suitable for its range of uses. It is therefore important that the lighting scheme proposed is completely flexible and has a comprehensive adjustable control system that can allow the conditions to be easily altered to suit the event.

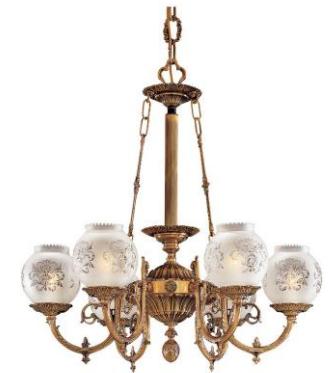
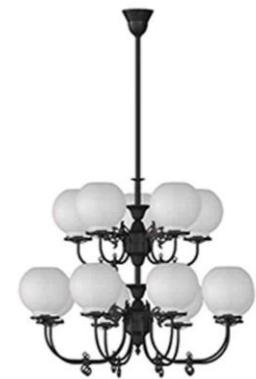
TRADITIONAL STYLE LED
CHANDELIER LIGHT FITTINGS

7.12 The existing chandelier style lights are somewhat out of place in a theatre auditorium. However, in this situation where the space is used for a variety of functions it is proposed that they remain so that they can be used instead of the entire auditorium lighting to provide lighting at a lower level for smaller events and functions. We would propose that they are replaced with fittings with LED lights such as the examples below.
